THE MODEL 32 TELETYPE ^R

MODEL 32

A. PREPARATION FOR CONNECTION TO AN ACOUSTICAL COUPLER

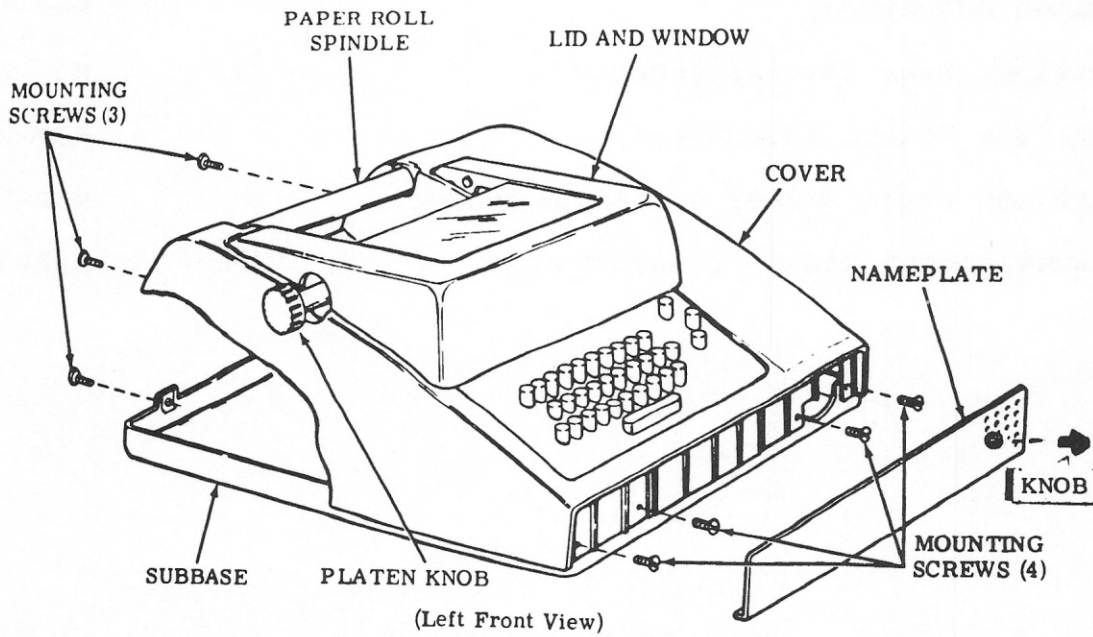
1. Fig. 32-1 shows the appearance of a Model 32. Be sure it is unplugged.
2. Fig. 32-2 shows the disconnecting procedure for removal of the cover.
 - a) Remove the two knobs.
 - b) Pull down the nameplate.
 - c) Remove the 7 mounting screws (4 in front & 3 in back).
 - d) Remove the paper roll.
 - e) Pull cover upwards.
3. Refer to terminal strip in Fig. 32-3. Remove the terminal strip paper cover.
4. Install 3 wire power cord, magnet, and keyboard wiring according to Fig. 32-4. More details are given in a schematic in Fig. 32-5.
5. Make sure the shipping screw (Fig. 32-6) is removed.

- a) Check with Fig. 32-15 to see if your paper follows the threading procedure.
- b) Make sure paper release lever is down in the normal position (Fig. 32-7).
- c) Paper roll spindle (Fig. 32-2) helps the paper feed through properly. Make sure you take it out of the empty paper roll before discarding the paper roll. Makeshift spindles sometimes hinder the paper roll from rotating smoothly, preventing the paper from feeding through properly.

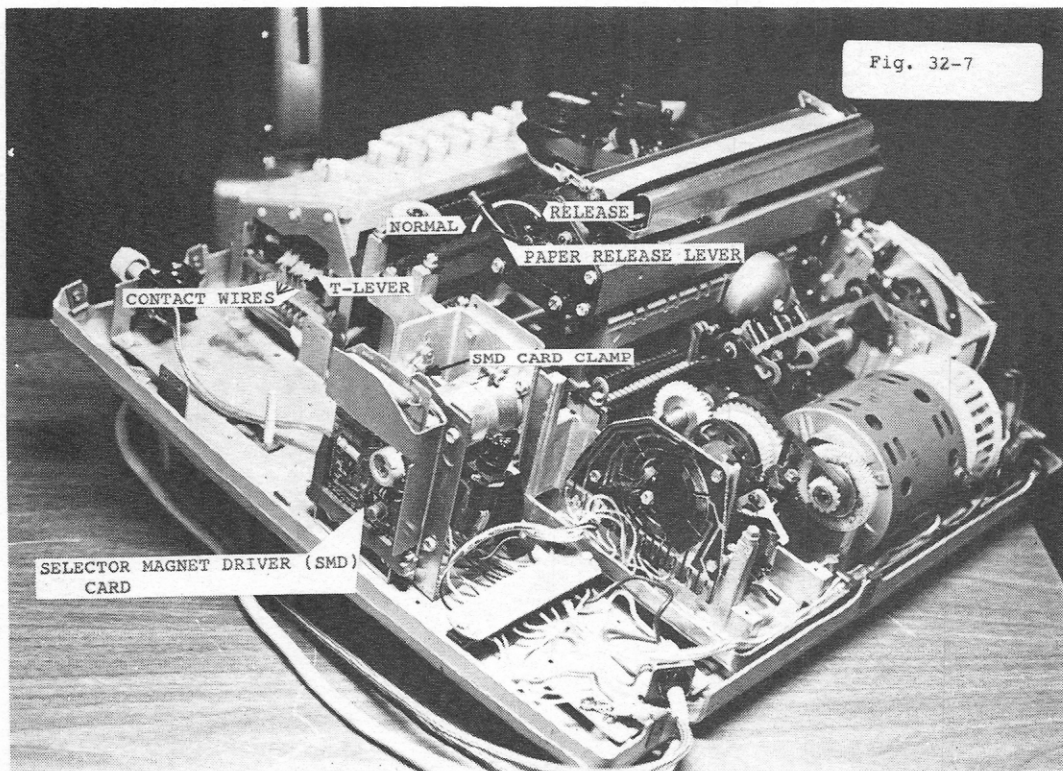
Fig. 32-7

- b) Check power supply fuse (Fig. 32-4).
 - c) SMD Circuit Card (Fig. 32-7) may have a bad transistor or diode. To remove card, first remove SMD card lamp.

- b) Oil may have gotten between the armature and pole pieces of the selector magnet. Refer to fig. 32-11.
 - c) Check that the contact wires are properly located in their T-lever. Refer to Fig. 32-7. Also check on contact wire gap away from common terminal. Gap should be 0.01 to 0.04 inches, gauged by eye. Refer to Fig. 32-27.

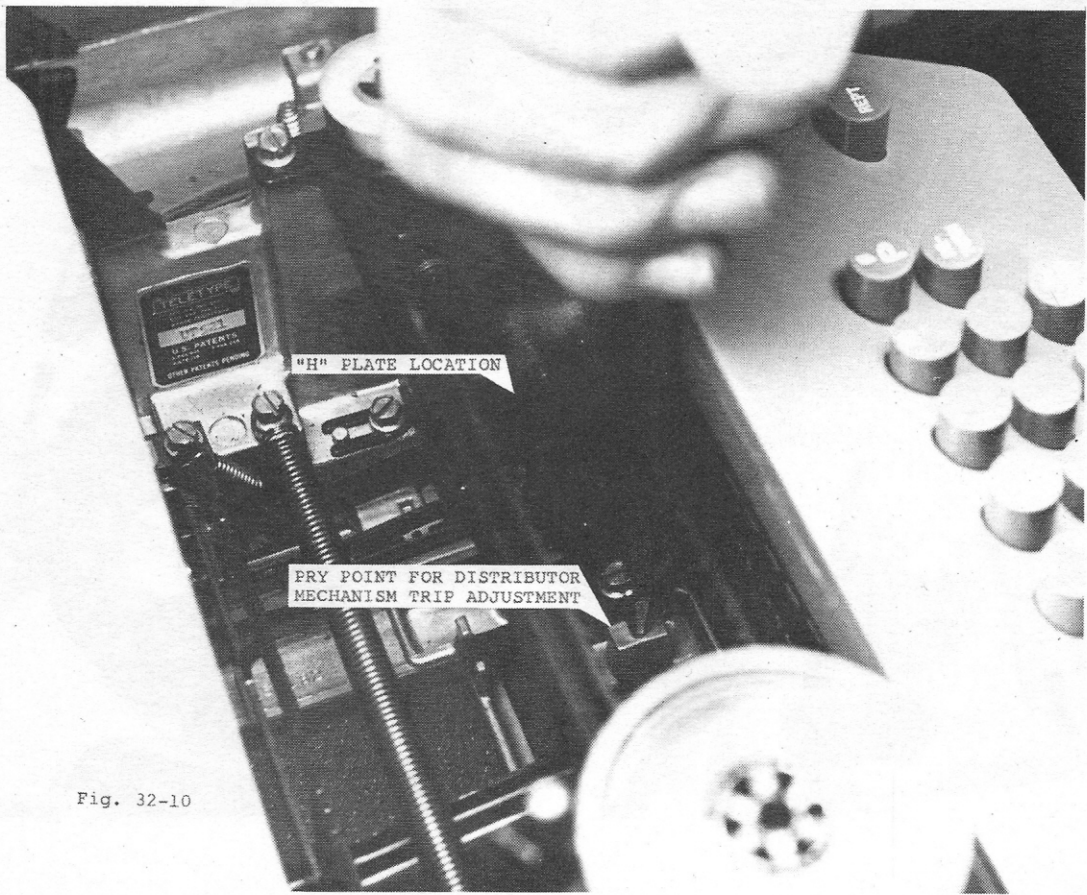
Fig. 32-10

- e) If your teletype will print when the other person types, but will not print when you type; check to see if the typing unit and the keyboard are properly connected by means of the "H" plate. Refer to Figs. 32-9 and 32-10.

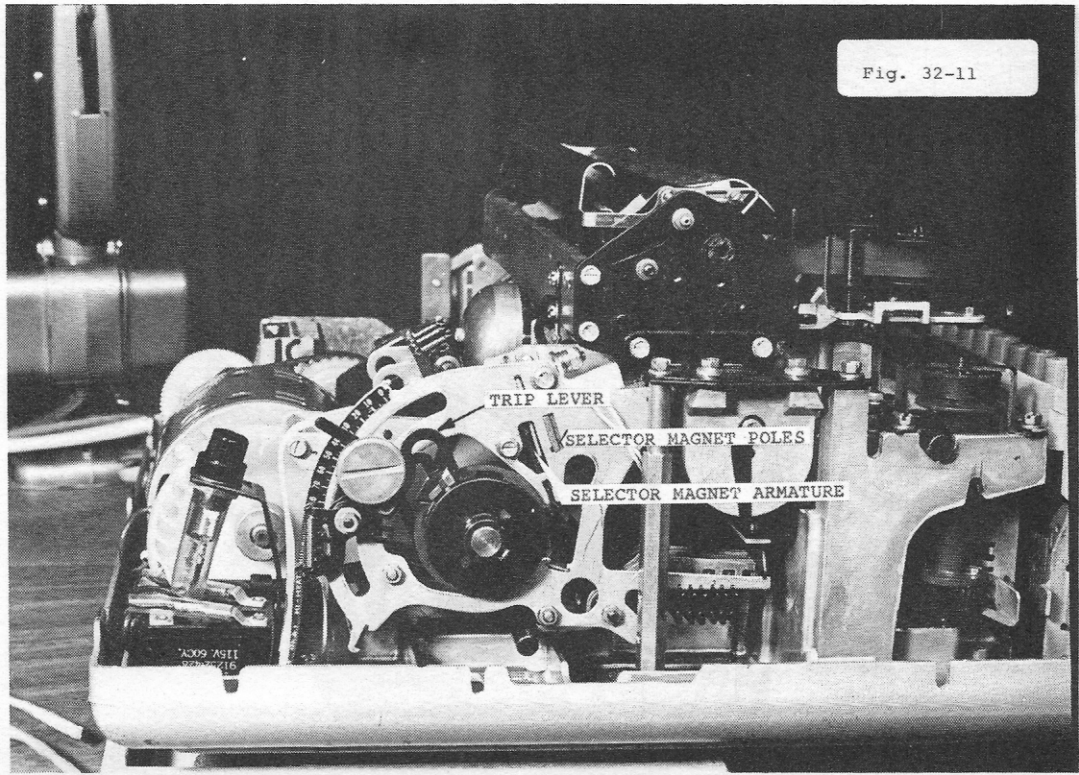
- f) Trip lever not adjusted properly. Refer to Fig. 32-11

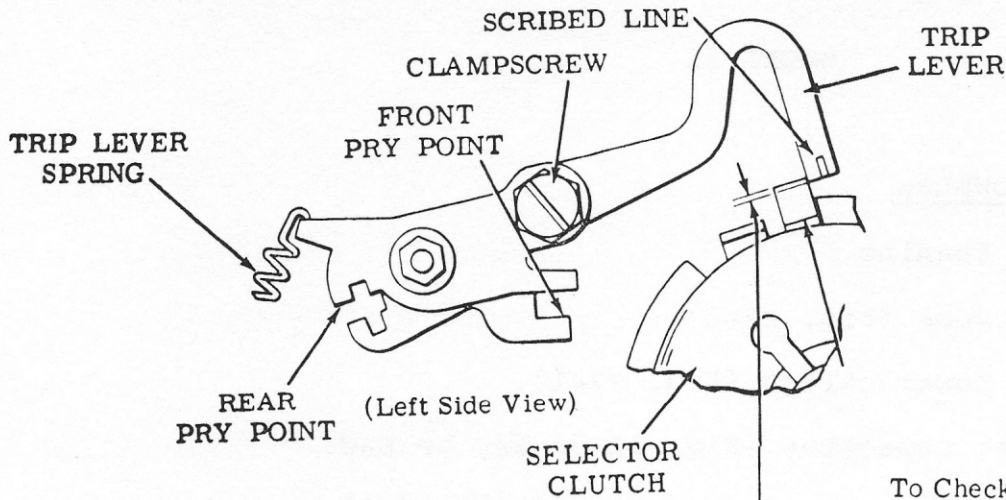
FIG. 32-12

To Check
Disengage (latch) selector clutch.

Requirement
Trip lever should engage shoe lever
Min 2/3 thickness
of shoe lever.

To Adjust
Loosen clampscrew friction tight and position trip lever using front and/or rear pry points. Tighten clampscrew.

TRIP LEVER PULLED DOWN BY ENERGIZED SELECTOR MAGNET (MARK)

for location. Trip lever should engage shoe lever during idle condition while selector magnet is energized. See Fig. 32-12 for adjustment instructions. Adjustment is easier if performed with power turned off. Use thumb to rotate gear and screwdriver to move armature as shown in Fig. 32-14. After adjustment according to Fig. 32-12 is made, go to the second adjustment procedure in Fig. 32-13. Make sure scribed line is in line with edge of shoe lever. You may have to go back and forth between the two adjustments to get a good adjustment.

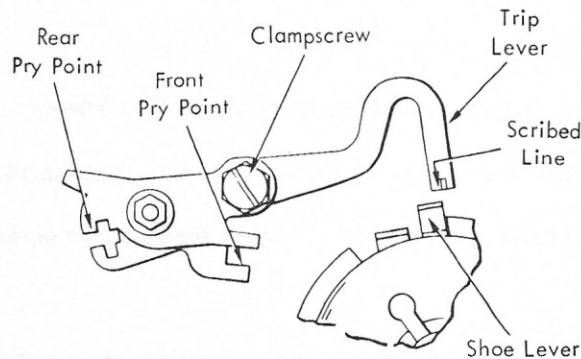
FIG. 32-13

NOTE: SCRIBED LINE SHOULD LINE UP WITH EDGE OF SHOE LEVER.

To Adjust
Loosen clampscrew. Use front pry point to meet Requirement (1); use rear pry point to meet Requirement (2).

TRIP LEVER RELEASED BY DE-ENERGIZED SELECTOR MAGNET (SPACE)

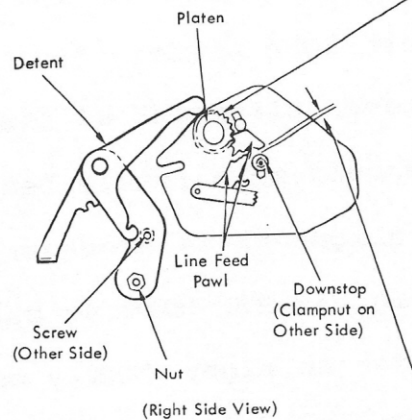
Fig. 32-17

With the line feed pawl placed in its lowest position:

- (1) Pawl held forward should fully mesh with platen teeth.
- (2) Platen should not rotate when detent is held outward then released against platen.

- (3) Min some---Max 0.010 inch between pawl and downstop.

- d) Line feed may not be working properly. Hit "Repeat" key and line feed key and observe the action of platen teeth and detent in Fig. 32-16. Another figure reference is Fig. 32-17. Detent and platen teeth should fully mesh at an even rhythmical pace. If pace is uneven, adjustment information is provided in Figs. 32-17, 32-18, and 32-19. The order of adjustment cannot be determined; it is up to the best judgement of the repairman. Location reference of line feed parts is given in Fig. 32-20.

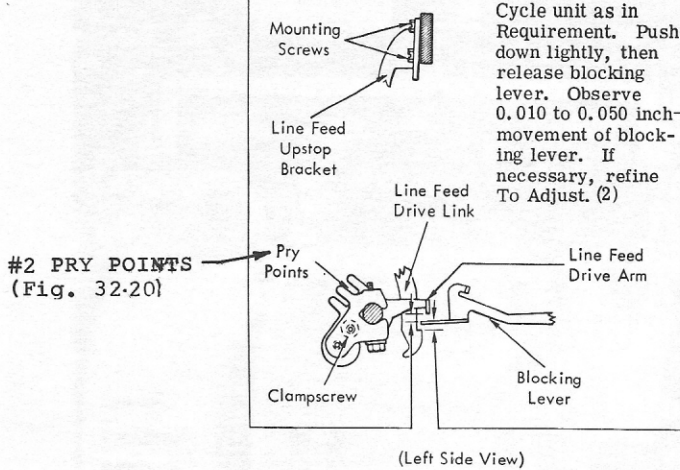
Fig. 32-18

With line feed code in selector, rotate main shaft to pivot line feed drive arm to its highest position. There should be a gap between drive arm and blocking lever, and the blocking lever should engage the drive link as illustrated.

- (1) If no gap exists, loosen clampscrew (friction tight) and reposition drive arm. Check 6.14 Requirement (2).
- (2) If gap exists but drive link does not engage blocking lever, loosen mounting screws and lower upstop bracket.

Cycle unit as in Requirement. Push down lightly, then release blocking lever. Observe 0.010 to 0.050 inch movement of blocking lever. If necessary, refine To Adjust. (2)

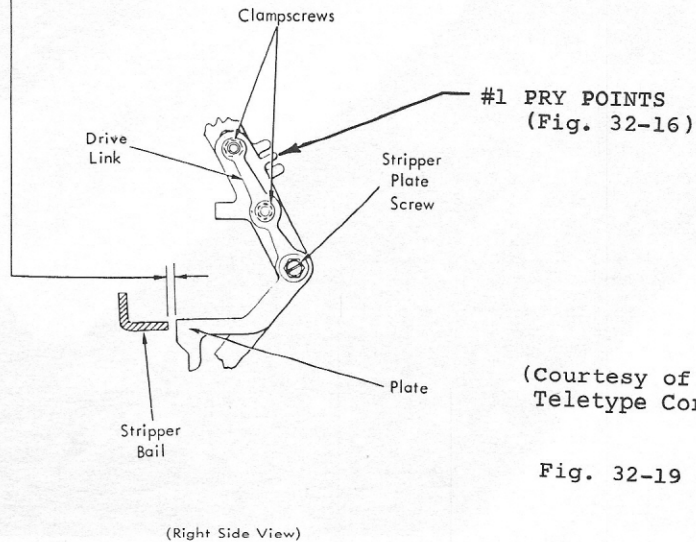
Fig. 32-19

- (4) Min some---Max 0.005 inch between stripper bail and plate.

To meet Requirement (1), loosen nut and screw and position detent. For Requirement (2), loosen clampscrews and position drive link -- if necessary, decrease gap of 6.13 Requirement (1). For Requirement (3), loosen downstop clamp nut and position downstop. For Requirement (4), loosen stripper plate screw and position plate.

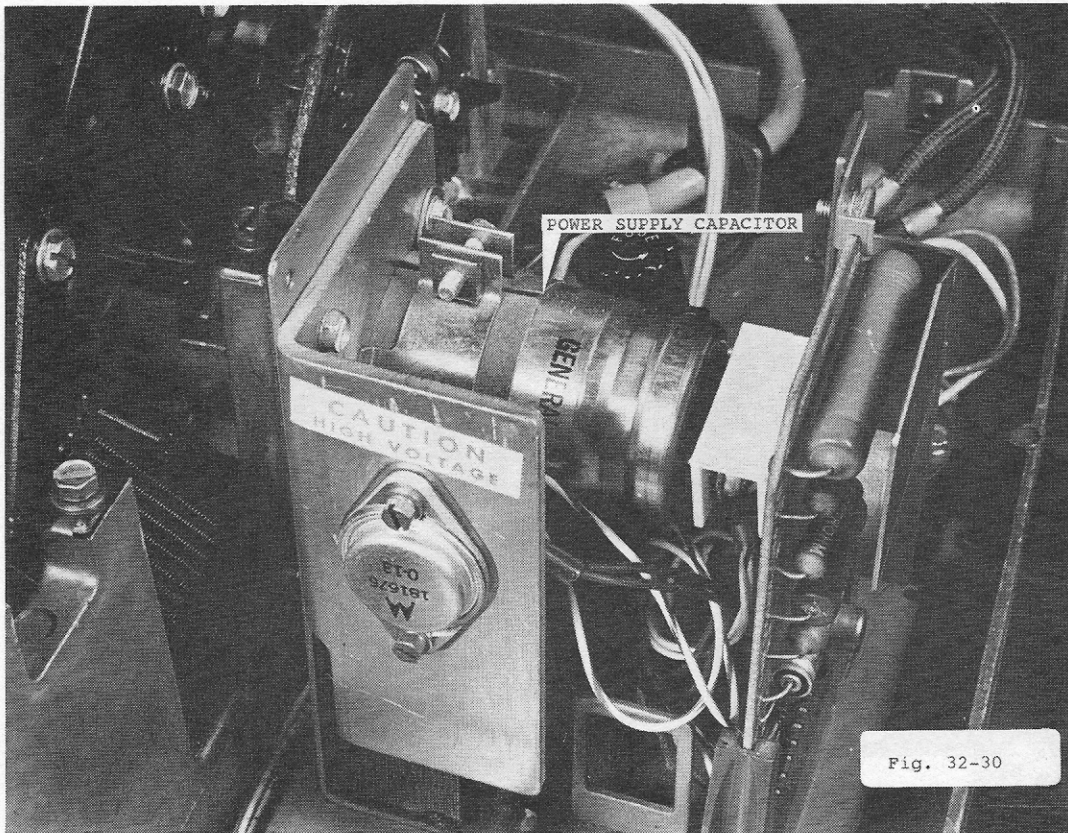
Fig. 32-30

- f) Power Supply Capacitor (Fig. 32-30) may have gone bad. Magnet current will drop from 500 mA to about 300 mA with this bad capacitor.
- g) Adjustment plate (Fig. 32-31) may be too far towards the front. Inspect and determine position of plate. If too far in front, adjust plate a little farther back.

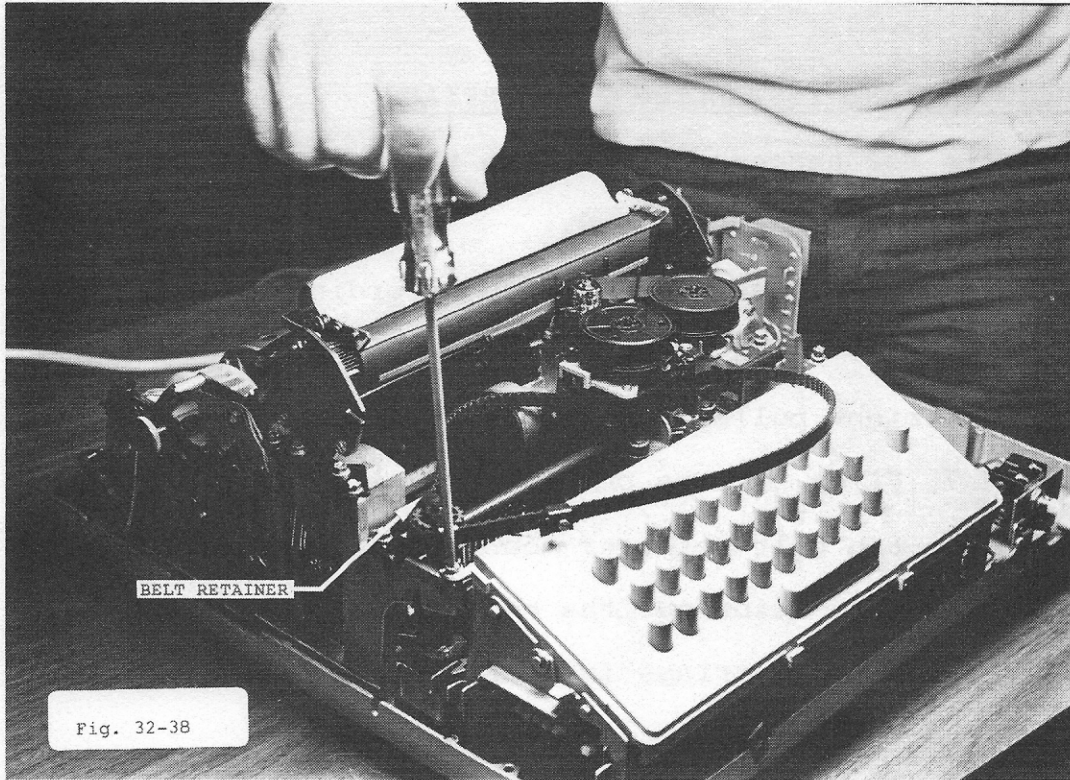
Fig. 32-38

1. It is not necessary to remove the typing unit to remove just the carriage.
2. Remove carriage return spring according to Fig. 32-36.
3. Loosen right pulley mounting screws according to Fig. 32-37. Slide out the pulley.
4. Loosen the belt retainer mounting screws according to Fig. 32-38. Slide out the belt retainer.
5. Pull out the carriage front rail according to Fig. 32-39.
6. Carriage is now pulled out. See Fig. 32-40.
7. To install carriage, reposition carriage as shown in Fig. 32-41 and make sure that the rollers engage the carriage rear rail.
8. Using screwdriver as shown in Fig. 32-41, lift slides over code bars. Carriage should be tilted slightly to the left. Slides should ride on the codebars as shown in Fig. 32-42.
9. Reinstall the carriage front rail and make sure the notch on the left side of the rail is aligned with the nip in the belt retainer.

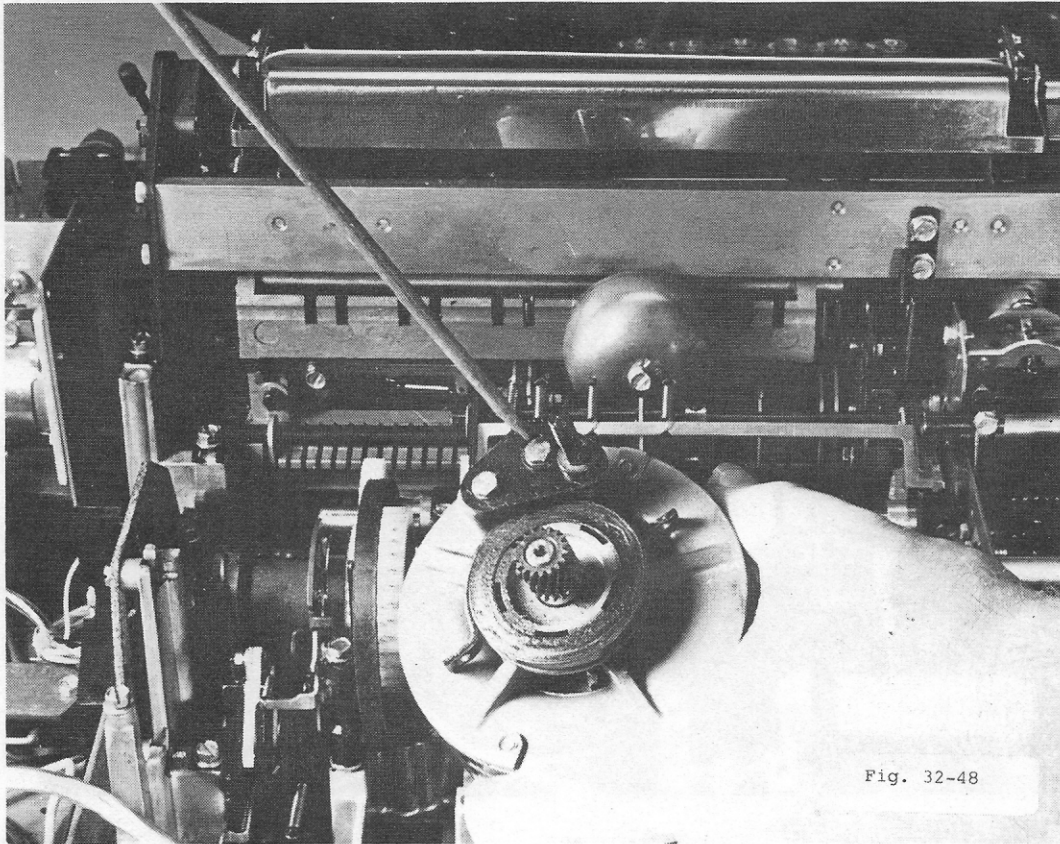
Fig. 32-48

1. Remove the 4 motor mounting screws according to Fig. 32-43.
2. Slide the motor driven belt off and lift motor according to Fig. 32-44.
3. Pull out snap ring according to Fig. 32-45.
4. Remove nylon gear according to Fig. 32-46 and check pinion for extent of wear.
5. When replacing gears, make sure that gear and pinion are meshed NOT TOO LOOSE or TOO TIGHT. Refer to Fig. 32-47. Adjustment can be made by referring to Fig. 32-48.
6. Reinstall motor and replace belt. Adjust tension of belt according to Fig. 32-49.
